SLIPPING THE BLOCK—WHAT IT IS AND HOW TO SPOT IT

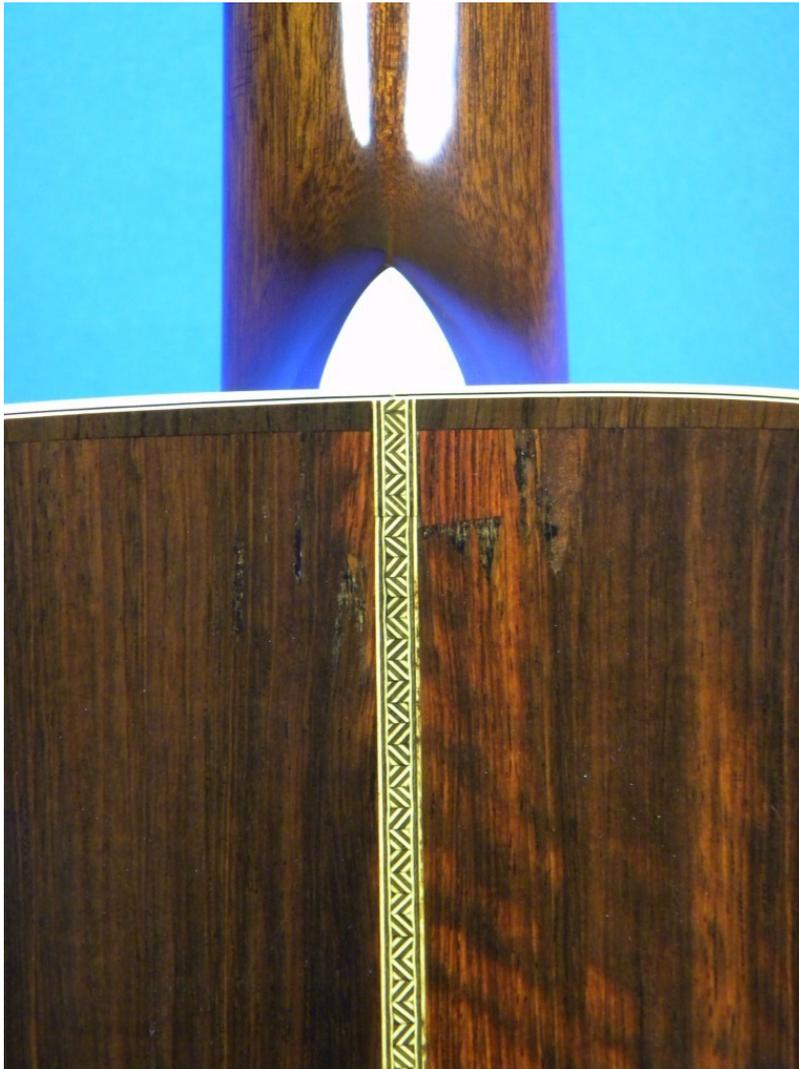
The picture below is of a '35 D-28 that had had the block slipped. The Martin factory reversed the procedure in 2010/2011. It illustrates the amount of back wood that is removed when the block is slipped.
